Cable diagnostic in MV underground cable networks

Theoretical background and practical application

- VLF testing
- tan delta loss factor measurement
- Partial discharge localization and measurement

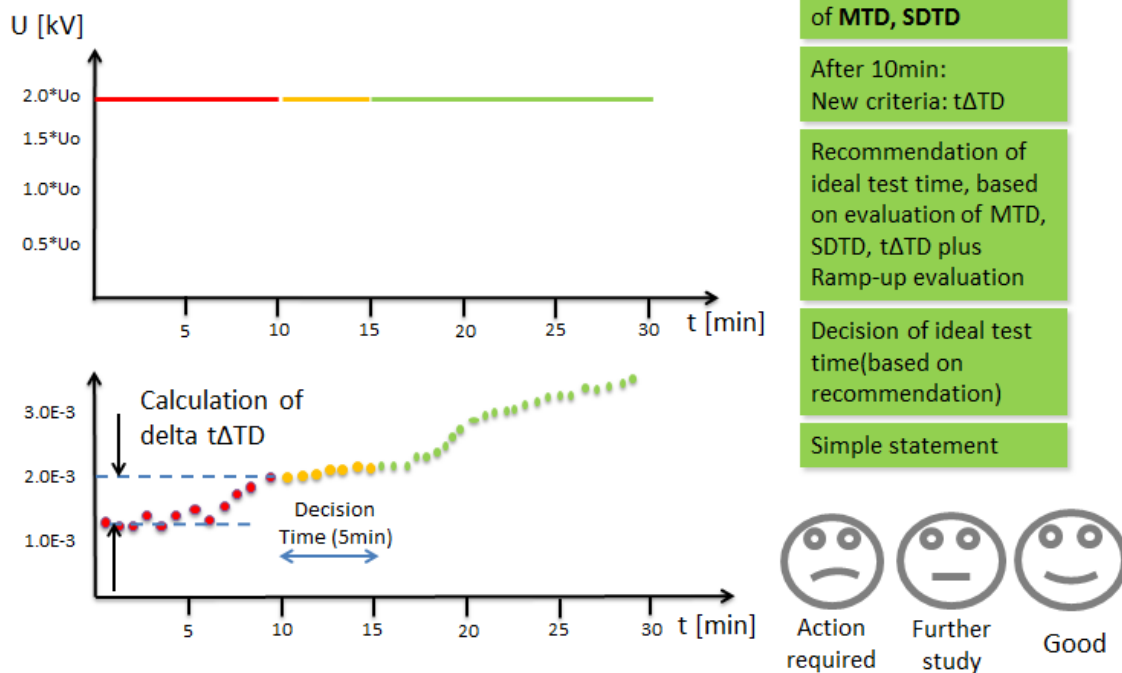
Figure 18, illustration of MWT / Hold stage

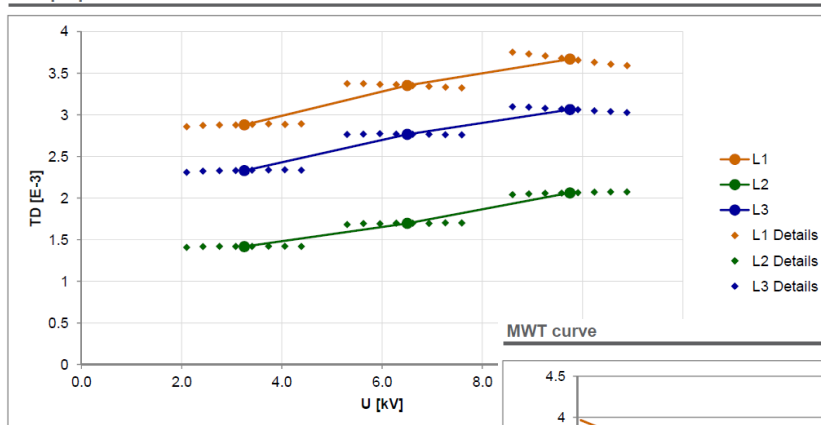
Figure 22, Ref. 12518CM, Ramp-up, decreasing trend

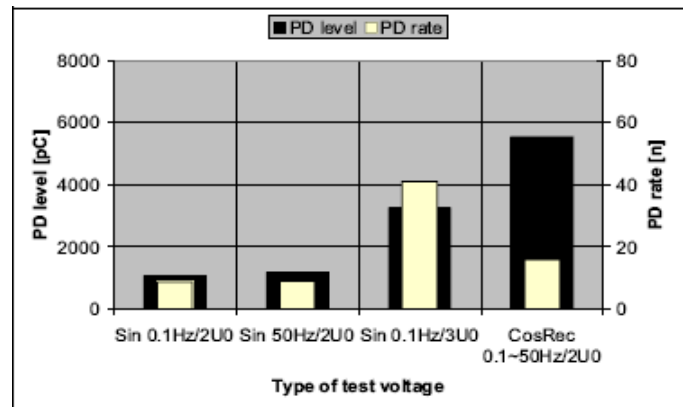
The comparative characteristics of Partial Discharge behaviour at 0.1 Hz and 50 Hz is shown in Figure 27. They show that VLF at 0.1 Hz has the **highest coincidence in relation to 50Hz**, whereas Cos-Rect. VLF waveform or oscillating wave OWTS are highly different in PD level and rate.

Figure 27 PD levels with 0.1 Hz sinusoidal wave shape, 50 Hz power frequency and Cos-Rectangular 0.1 Hz [16]

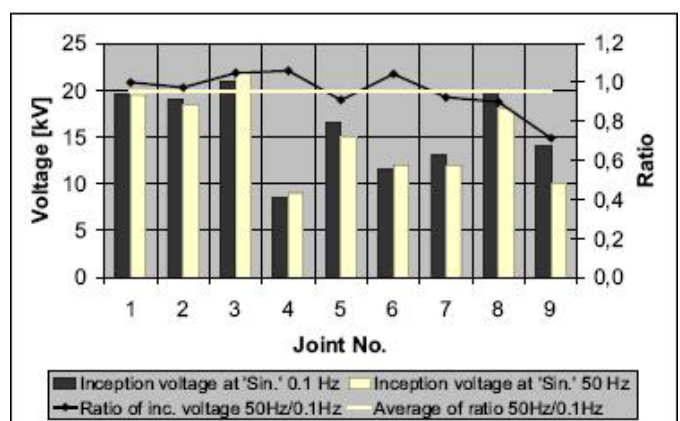
Results, based on sinusoidal waveform are shown in Figure 28. Quite similar results can be found in respect of PDIV. The **ratio is varying in all cases with less than 10%**. As we can see, also at higher voltage levels up to 80kV, the VLF is showing comparative results. Very similar PD patterns at higher sinusoidal voltage levels on different artificial joint faults on a 110 kV XLPE cable have been identified. [16]

Figure 28 Partial discharge inception voltage in comparison with HV source [16]

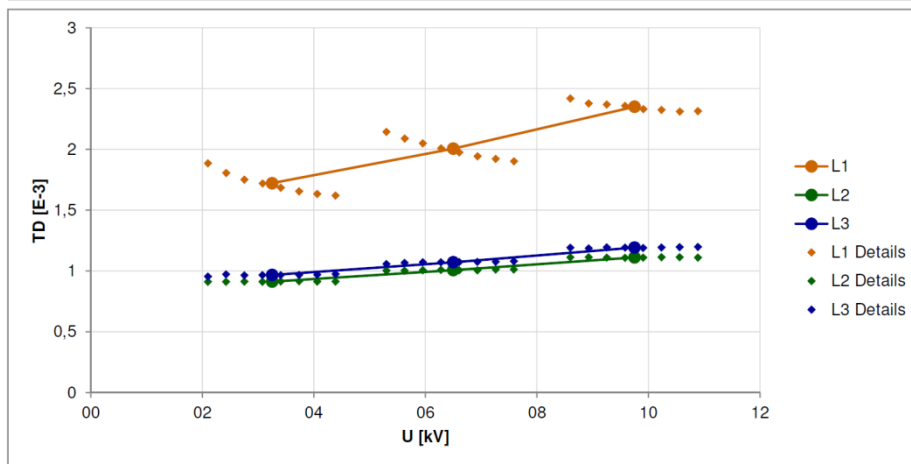
Figure 57, Ref. 2215CM, example L2, L3 stable condition, L1 water ingress in a joint

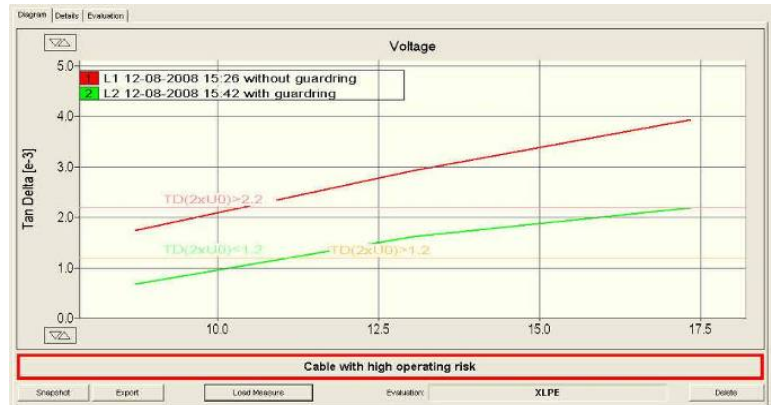
The shown TD graph shows an example, where the termination had been cleaned properly. The relative humidity was very high. Only by means of the guard ring application, the real loss factor of the cable could be measured.

Figure 62 direct comparison of the TD value with guard ring application and without guard ring application

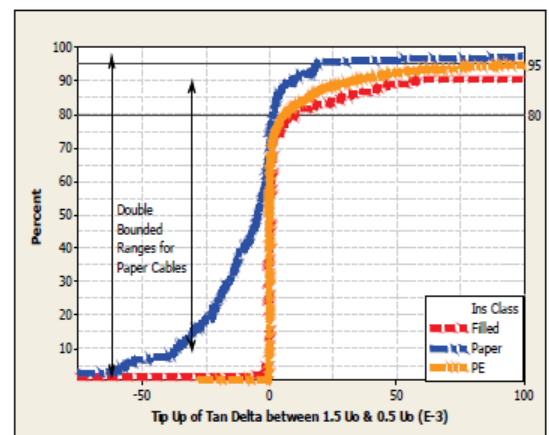
Figure 5 of [21] shows the distribution of Tip Up data for different ranges of Tip Up where Tip Up is the difference in Tan Delta measured at 1.5U₀ and 0.5U₀. As many workers have noted, it is quite common for PILC cables to show a negative Tip Up, however excessive negative values have been considered atypical in the same manner as unusual large ones.

Figure 5: Cumulative Distribution of all Cable System Tip Up Criteria – scale has been expanded to show negative Tip Up on the Paper cables

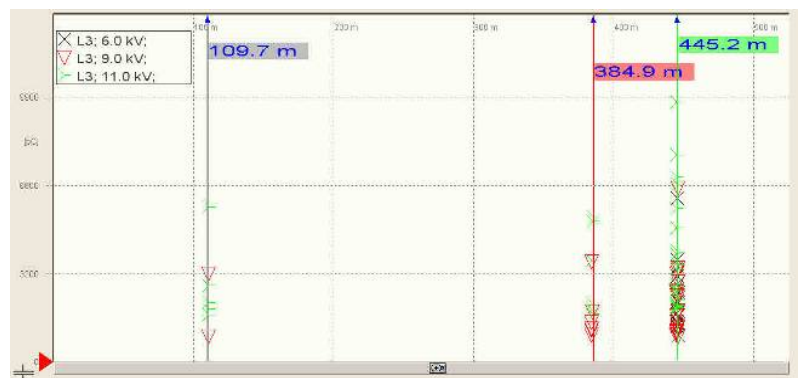
Figure 74 PD Localization Graph of a XLPE cable with 3 joints with PD activity

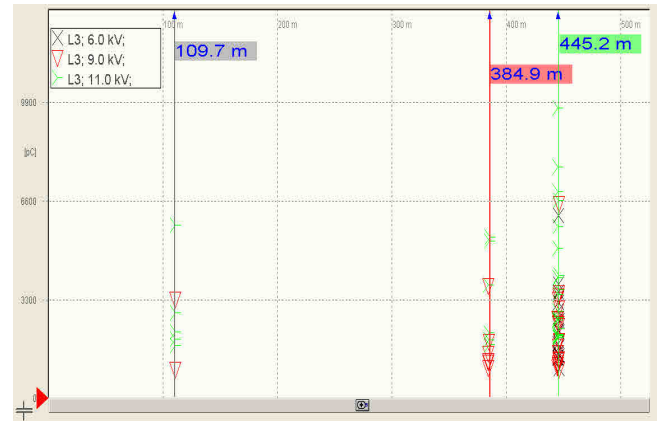
In XLPE and EPR cables PD activities mainly occur in cable accessories. PD in the XLPE insulation itself can be detected very rarely. If PD occurs in the XLPE insulation (electrical treeing) the cable will fail within a few days or maximum weeks. Therefore it is very seldom a PD Diagnostic is carried out exactly within this short time period. Another reason for PD activity in the XLPE cable section could originate to severe damages of the outer protective sheath.

Figure 90 PD graph of XLPE cable with PD activity concentrated at 3 joints

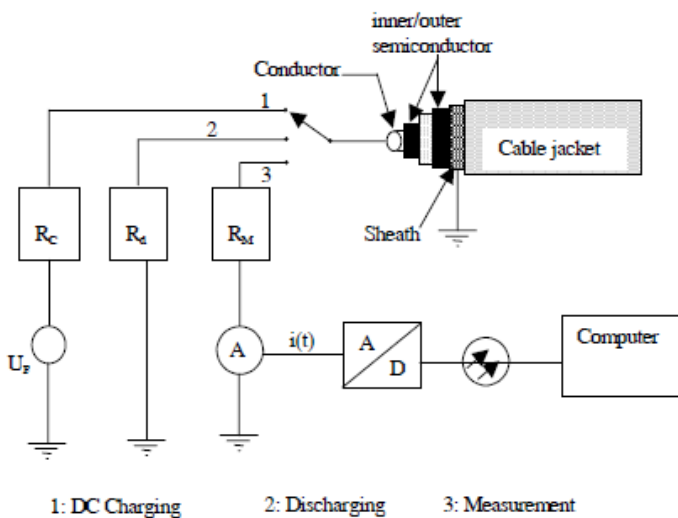
The Cable diagnostic instrument KDA 1 (Seba-Dynatronic) is based on the measurement of the depolarization current. The cable under test is charged at 1kV DC for 30 minutes. Then the cable is short-circuited for 5 seconds, and the depolarization currents are measured for the following 30 minutes (Figure 93). The measured data are saved and processed with Isothermal Relaxation Current (IRC) analysis. The depolarization current measured is described as the sum of three experimental functions where parameters a_j , τ_i are strongly correlated with the material properties. The time constant τ_3 is related to water tree degradation of the cable insulation.

Figure 93 Basic measurement circuit for the IRC – Analysis, KDA1

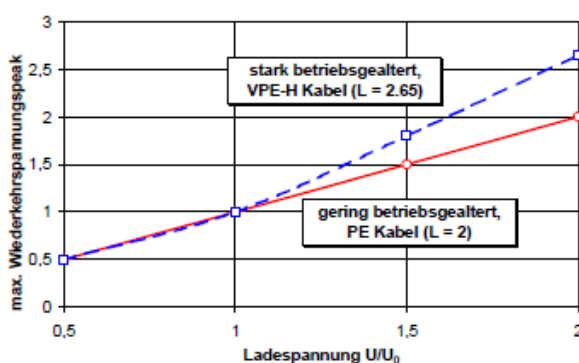
Bild 6: Rückkehrspannungsspeak in Abhängigkeit der Ladespannung für unterschiedlich stark geschädigte PE/VPE-Kabel (Meßbeispiel, $t_L = 5$ min, $t_K = 2$ sec.)

Figure 98 picture 9 of [24], Return voltage peak for differently aged PE/VPE cables

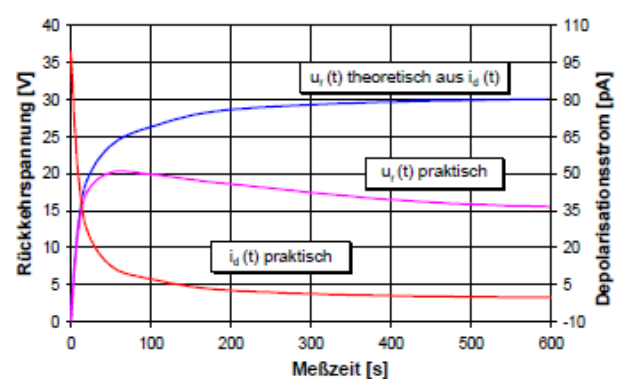
Bild 9: Vergleich zwischen der aus dem Depolarisationsstrom berechneten Rückkehrspannung und der praktisch erzielbaren Rückkehrspannung

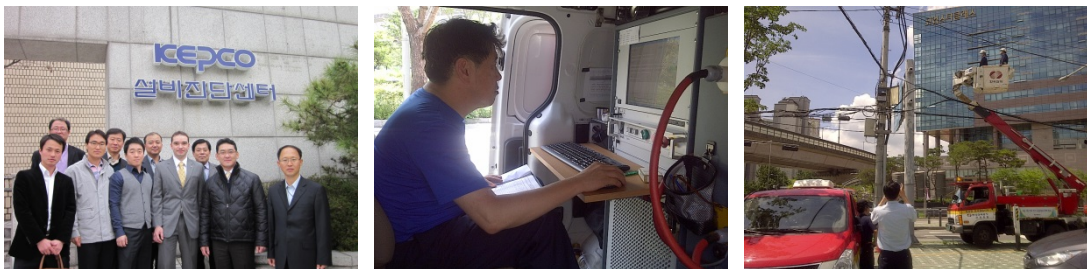
Figure 109: KEPCO Diagnostic Experience

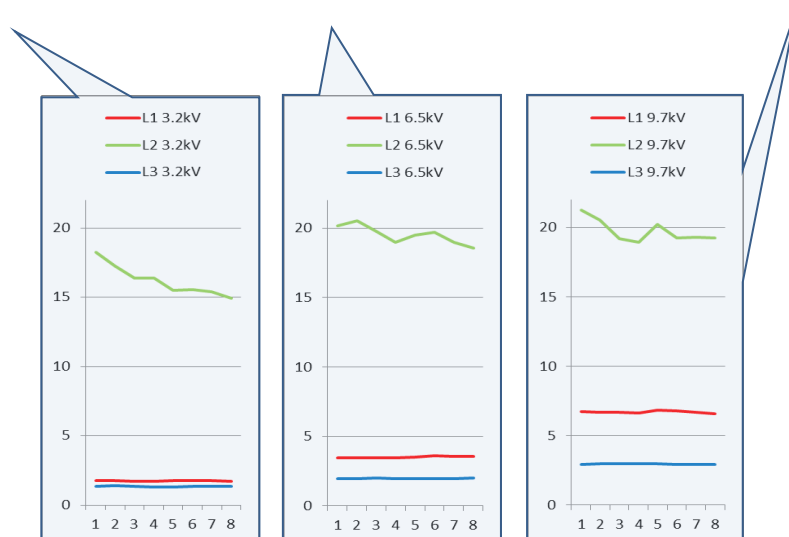
The results of the last 68m section (distance from the cut-point to the termination) of all 3 phases were also obtained after the cable failure on 30 JUL 2011. The TD results changed due to the cable length and homogenies cable composition (WTPCS without joints) and show that all cables have high operating risk and L2 has the worst result. The delta TD values for all 3 phases are extremely high which is far beyond the acceptable limit and high water tree aging and water ingress in a joint in L2 is to be expected; therefore it is necessary to investigate the cables in further details.

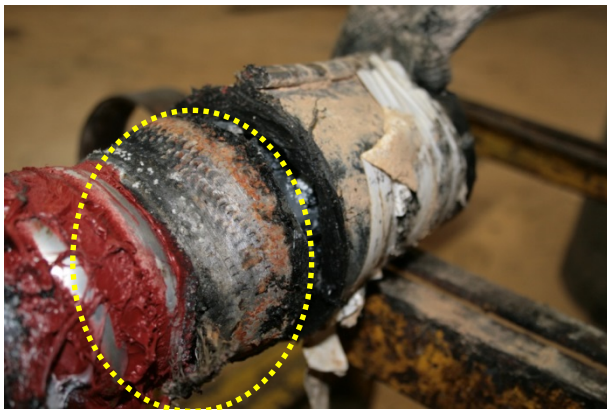
Fault point on L3 at Sumitomo

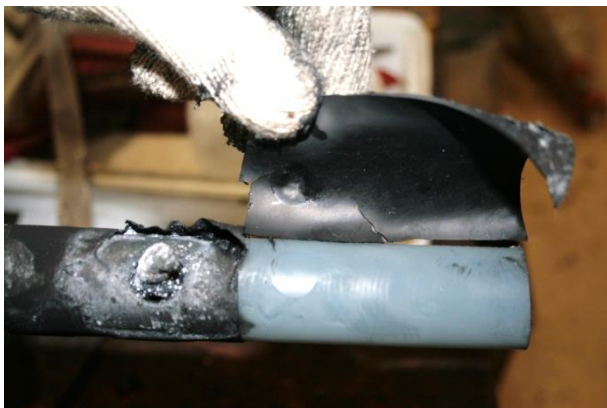
Water sign noted in insulation screen

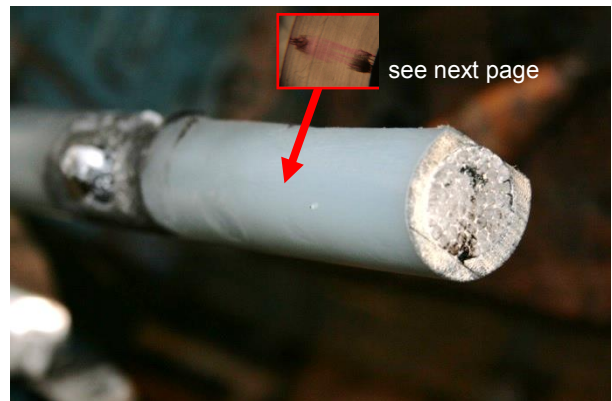
Suspected water tree developed near to fault point

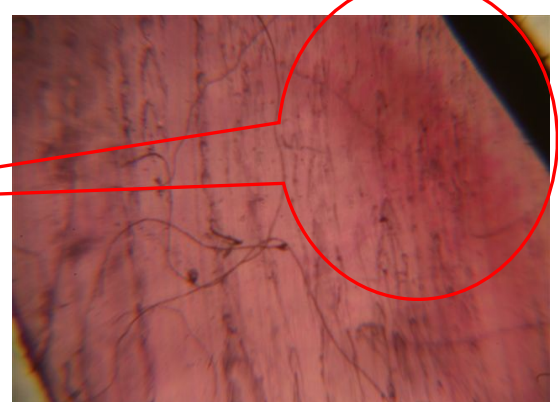
Spot #3 dissection, colored / microscope picture of severe water tree
